**CTA Bus Slow Zone Study
Final Project Report
CTA Route #79
79th Street**

**Prepared for:
Chicago Transit Authority
Chicago Department of Transportation**

**By:
Stanley Consultants Inc.
EJM Engineering Inc.**

**Final
June 2018**

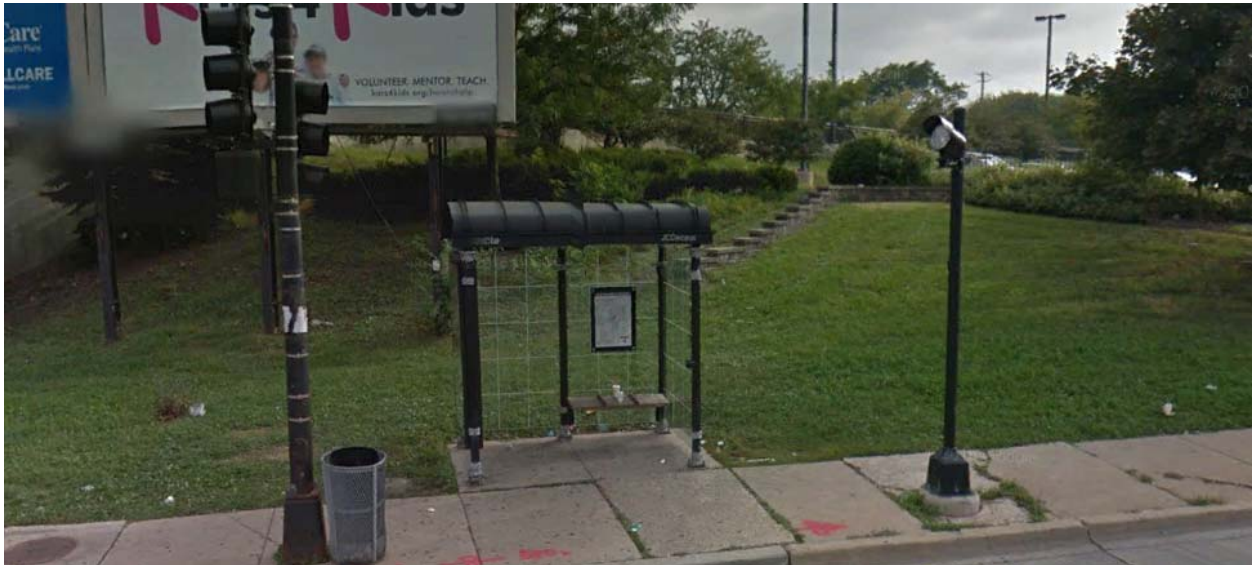
Figure 1: Southwest Corner of 79th - Kedzie Bus Stop and Shelter

79th Street and Kedzie Avenue. Bus shelters are located at the two bus stops at 79th Street and Kedzie Avenue. See exhibits C-1 and C-2 for detailed physical characteristics.

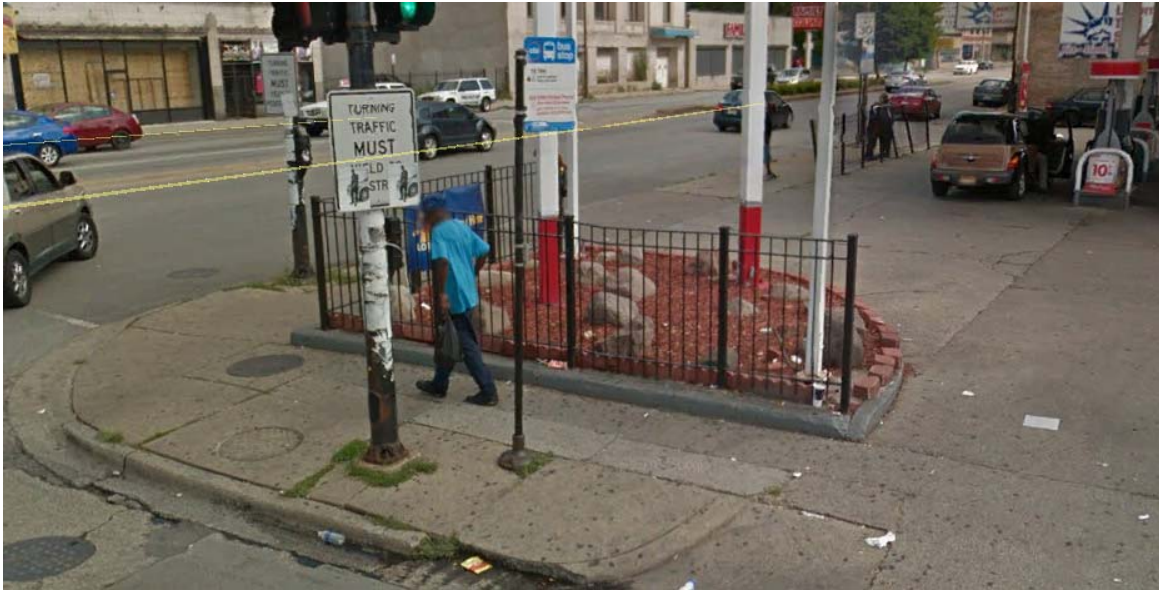
Figure 2: Southwest Corner of 79th - Ashland Bus Stop

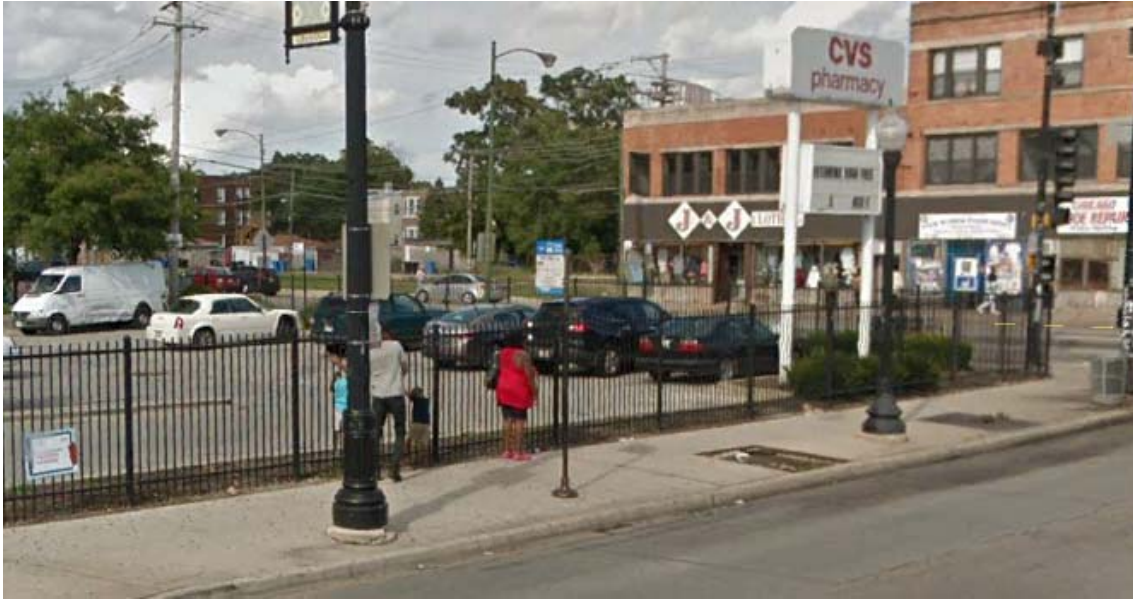
Figure 3: Northwest Corner of 79th - Halsted Bus Stop

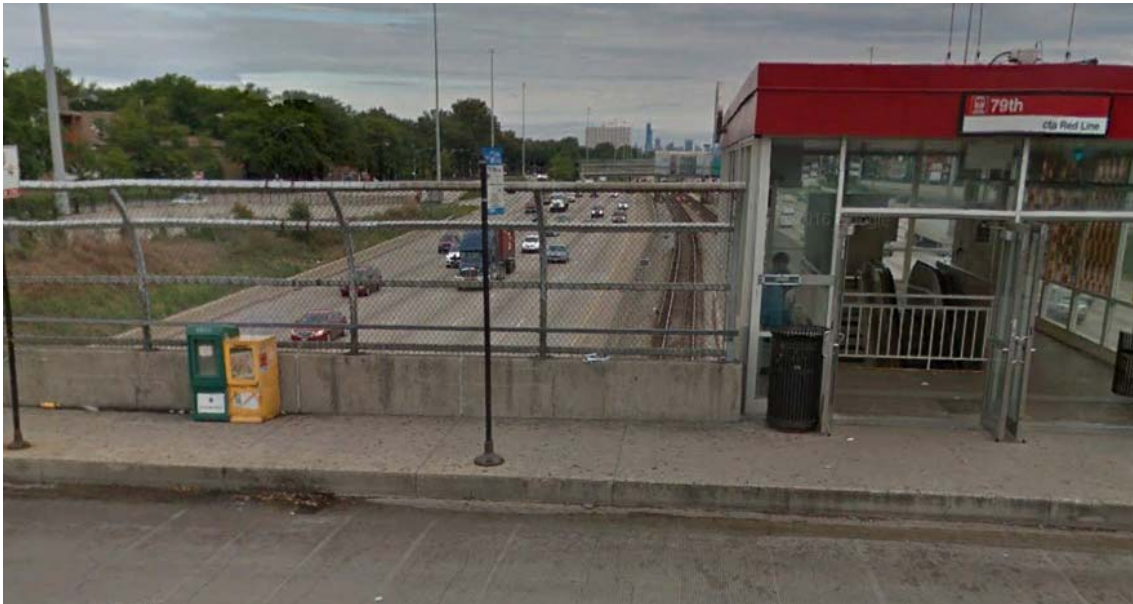
Figure 4: North Curb Bus Stop between Lafayette and State

Pavement markings are extremely worn between Lafayette Avenue and State Street. Drivers were observed using the bus lane as a through lane. Eastbound bus delays were caused by non-CTA vehicle drop-offs and Chicago Police Department Transit Police vehicles parked in the bus lanes. CTA buses frequently bunched together at the midblock bus stops. This caused delay and confusion for boarding passengers, as most would try to board the first bus nearest the bus stop (often crowded) and others would walk to the other bus. CTA buses would often stand still for several minutes after loading. Significant volumes of pedestrians were also observed using the south leg crosswalk of Lafayette Avenue. However, these pedestrians did not significantly delay eastbound to southbound right turning vehicles and negatively impact eastbound CTA buses. See exhibit D-4 for more detailed travel characteristics.

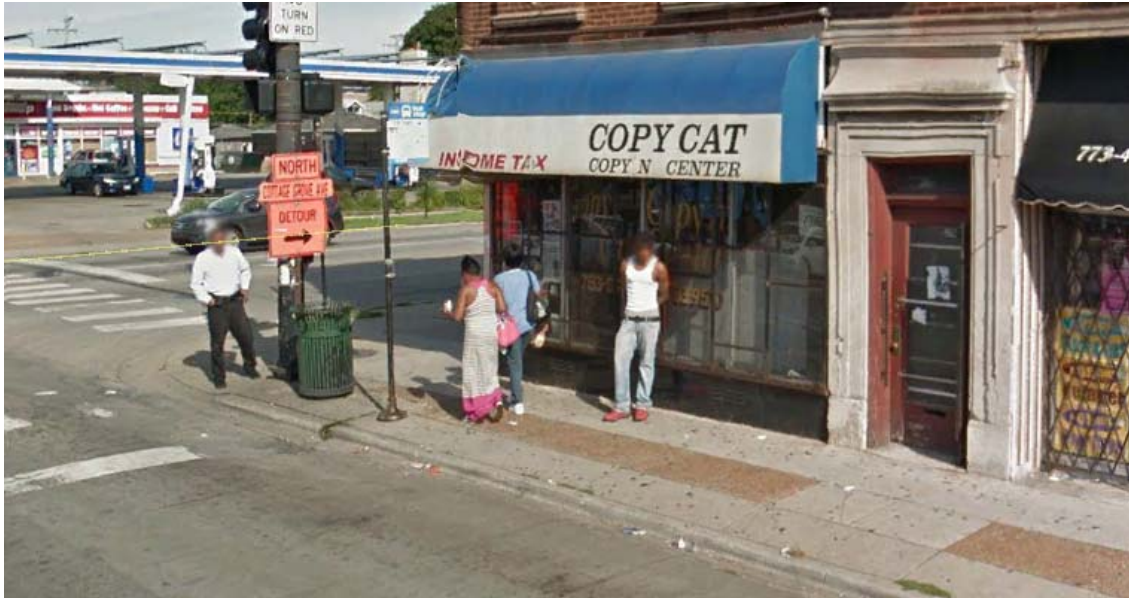
Figure 5: Northeast Corner 79th - King Bus Stop

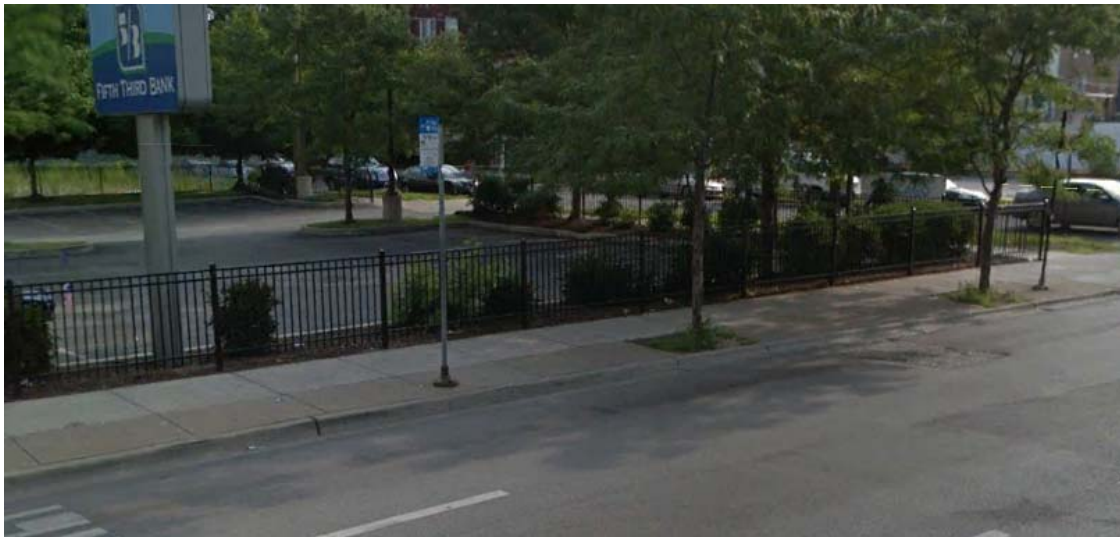
Figure 6: Northeast Corner Stony Island - South Chicago - 79th Bus Stop

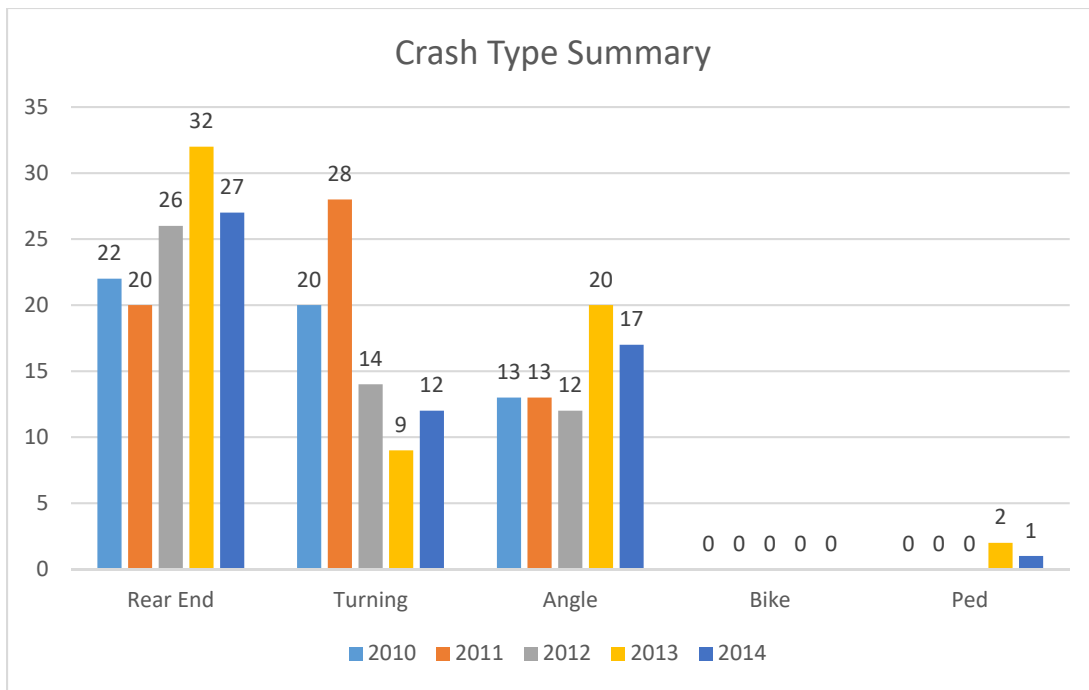
Figure 11: Crash Type Summary for Kedzie Avenue / Columbus Avenue

The most prevalent crash types were Rear End, Turning, and Angle collisions which accounted for 35 percent, 23 percent, and 21 percent of the total crashes reported, respectively. Of the 365 crashes, 80 of them involved injuries of Type B or C severity. There was 1 fatal crash and 14 crashes that resulted in Type A injuries.

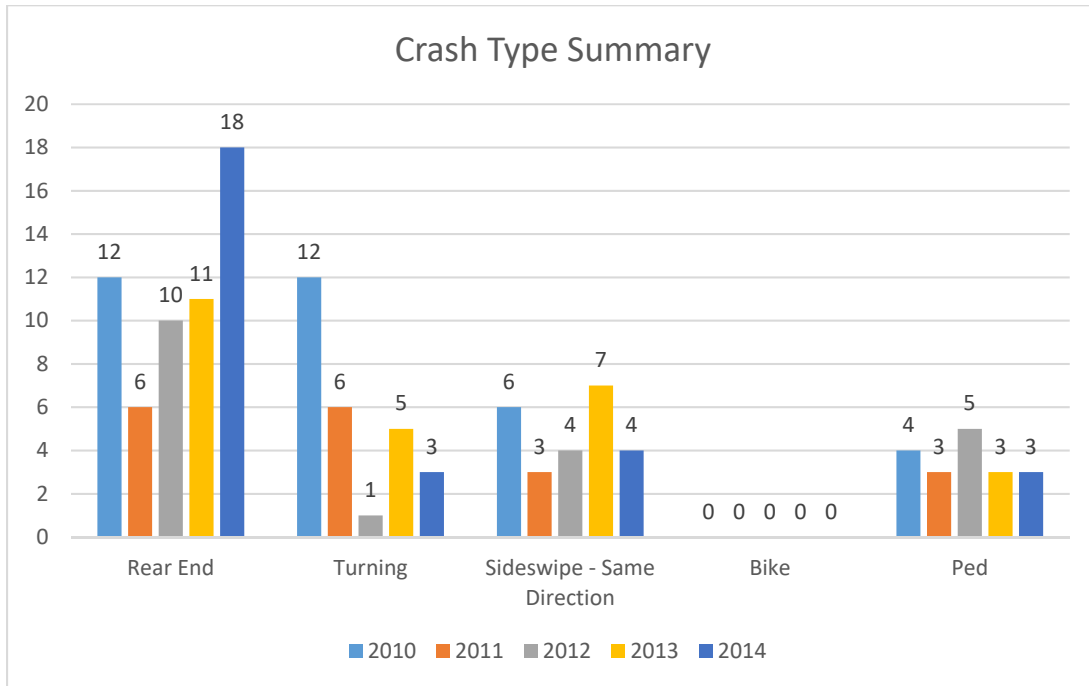
Figure 12: Crash Type Summary for Ashland Avenue

The most prevalent crash types were Rear-End, Turning, and Sideswipe – Same Direction, which accounted for 37 percent, 17 percent, and 16 percent of the total crashes respectively, respectively. Of these 155 crashes, 43 collisions involved injuries of Type B or Type C severity. There were 3 crashes resulting in Type A injury and no crashes resulting in a fatality.

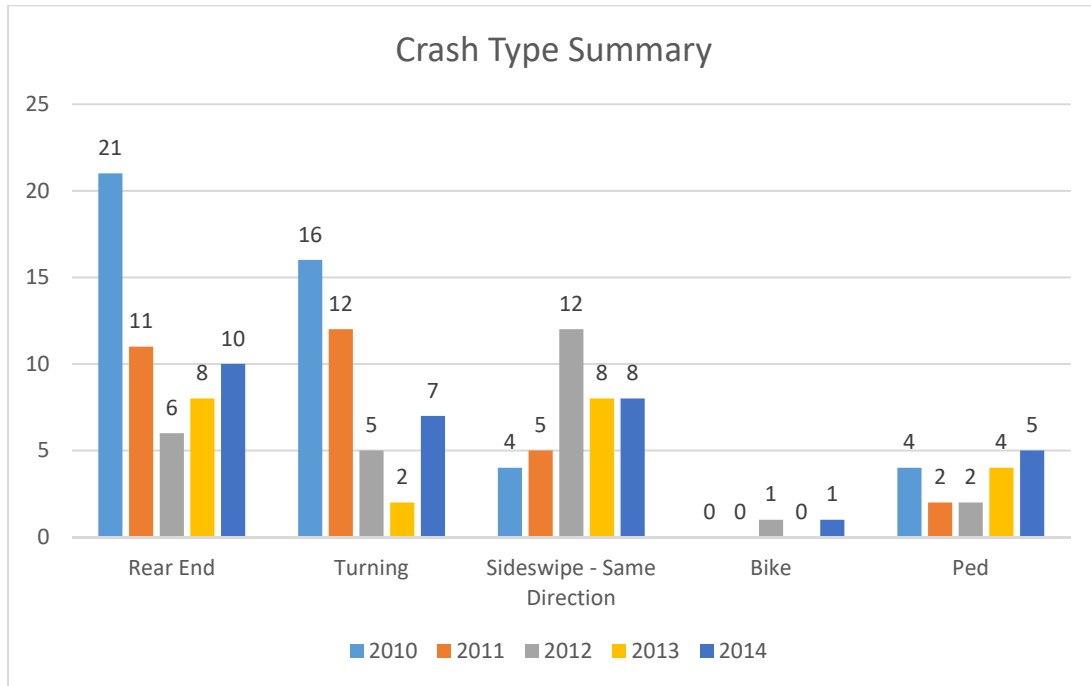
Figure 13: Crash Type Summary for Halsted Street

The most prevalent crash types were Rear-End, Turning, and Sideswipe - Same Direction collisions, which accounted for 29 percent, 22 percent and 19 percent of the total crashes reported, respectively. Of these 194 crashes, 55 collisions involved injuries of Type B or Type C severity. There were no fatal crashes and 7 crashes that resulted in Type A injuries.

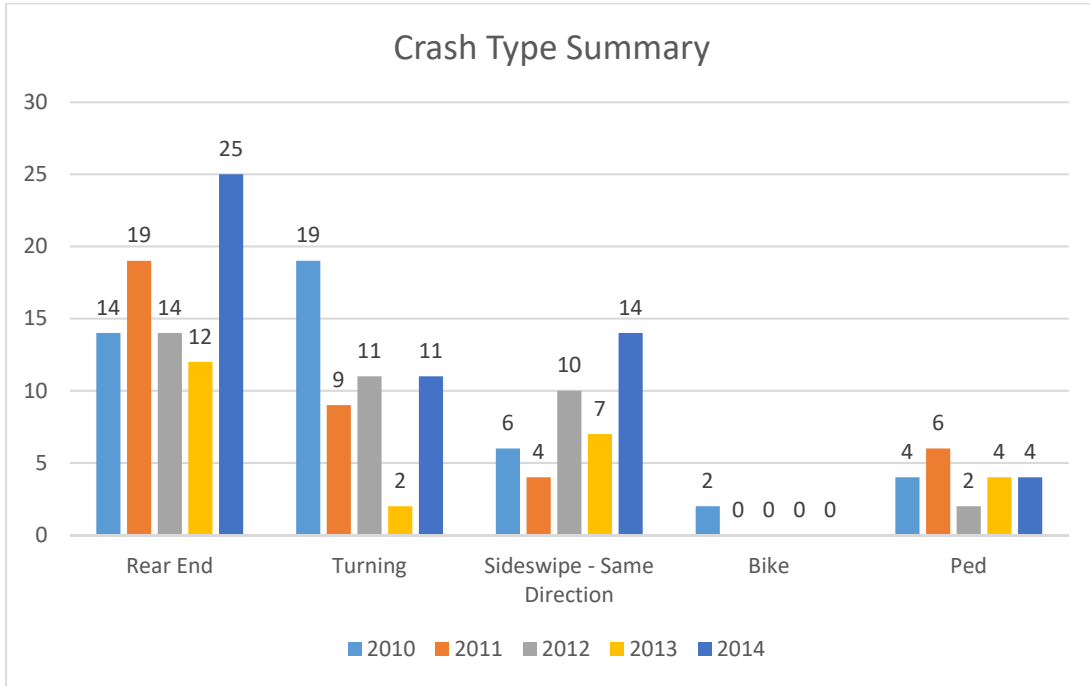
Figure 14: Crash Type Summary for Lafayette Avenue - State Street

The most prevalent crash types were Rear-End, Turning collisions, and Sideswipe - Same Direction, which accounted for 32 percent, 20 percent, and 16 percent of the total crashes, respectively. Of these 265 crashes, 55 collisions involved injuries of Type B or Type C severity. There was 1 fatal crash and 2 crashes that resulted in Type A injuries.

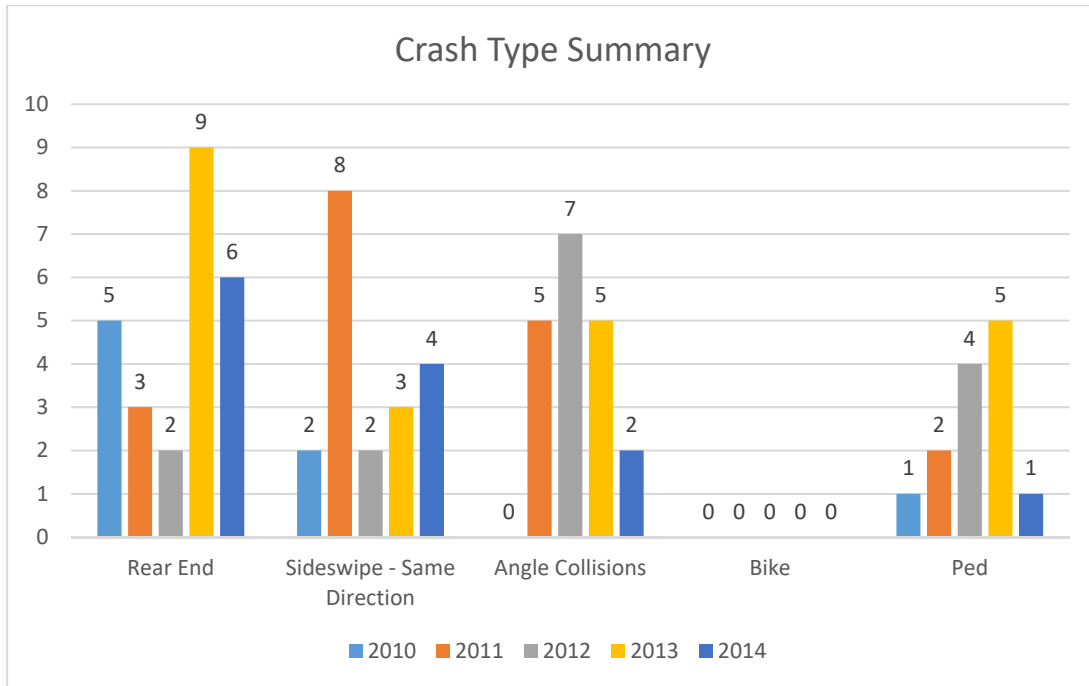
Figure 15: Crash Type Summary for Martin Luther King Drive

The most prevalent crash types were Rear-End, Sideswipe - Same Direction, and Angle collisions, which accounted for 22 percent, 16 percent, and 16 percent of the total crashes reported, respectively. Of these 116 crashes, 29 collisions involved injuries of Type B or Type C severity. There were no fatal crashes and 2 crashes that resulted in Type A injuries.

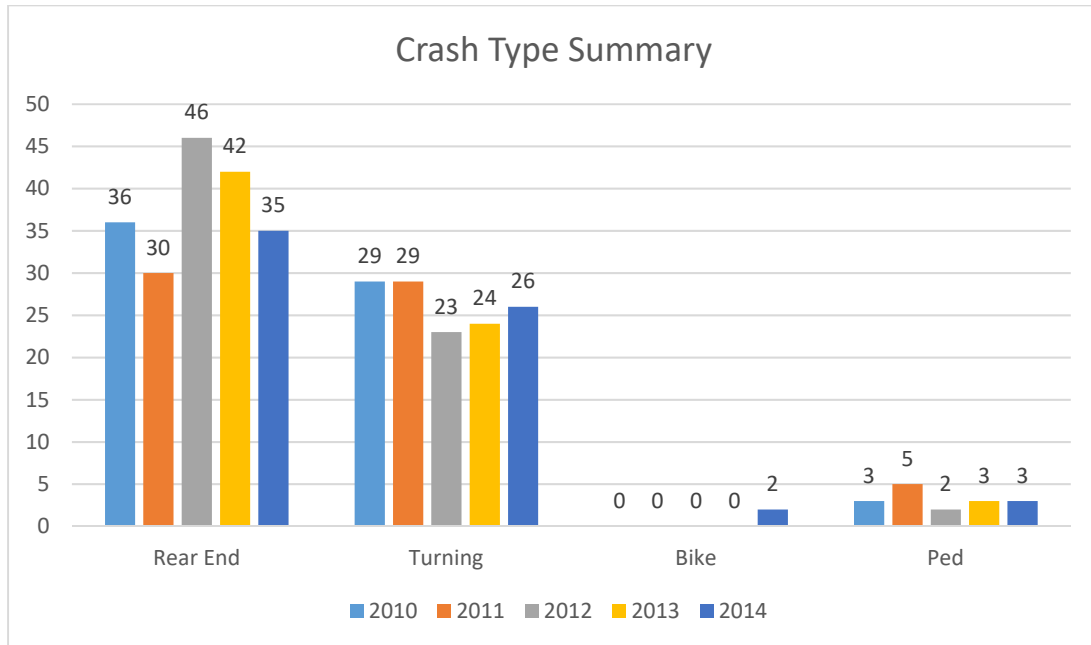
Figure 16: Crash Type Summary for Stony Island Avenue / South Chicago Avenue

The most prevalent crash types were Rear-End and Turning collisions, which accounted for 36 and 25 percent of the total crashes, respectively. Of these 523 crashes, 109 collisions involved injuries of Type B or Type C severity. There were 2 fatal crashes and 14 crashes that resulted in Type A injuries.
